# WARNING

## BEFORE INSTALLING THE CR INJECTOR, THE FOLLOWING STEPS MUST BE CONDUCTED UNCONDITIONALLY:

## Common reasons for unjustified claims

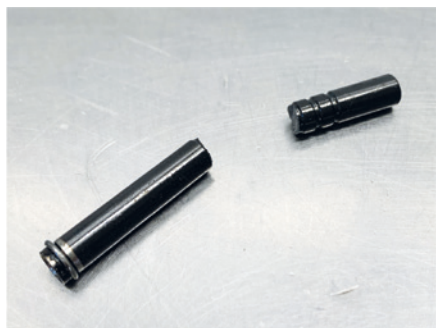
### Damaged internal element

Due to bad torque tightening of the injector.

**8** Hold the adjustment screw in this position and tighten it to the manufacturer specified tightening torque.

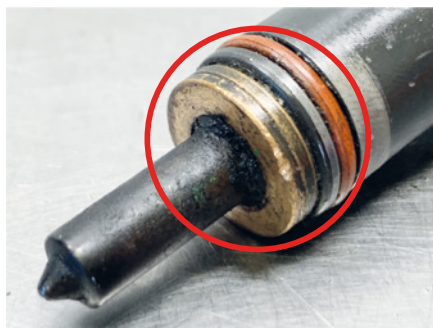
### Uncleaned contact area surfaces

Insufficiently cleaned and leveled.

- Clean the nozzle bearing area.
- Install injectors using only new heat washers.

**3** Contact area - grind the sharp edges.  
This will prevent damage to the sealing rings.
